Manhole Inspection Summary

Manhole # S69M__003MH

Location Address: **6525 O'Donnell St.**

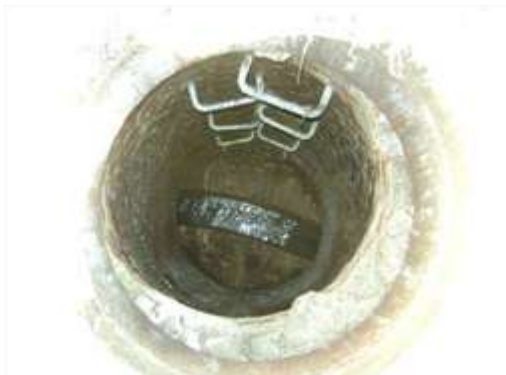
Defect 1

Frame Offset: **3** (in.) Condition: ☐ Sound ☒ **Cracked** ☒ **Leaks**

3 in. frame offset

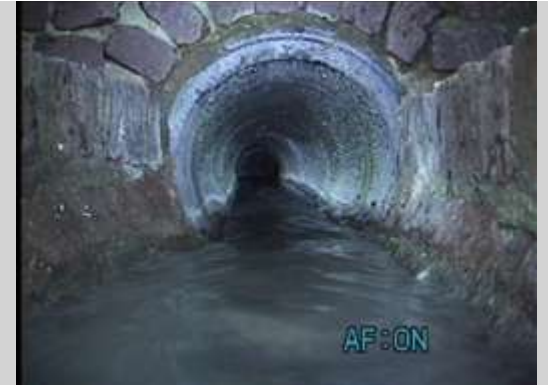
12 O'Clock Outflow

Pipe Height: **12** (in.) Rod and Bar (Angled)
Pipe Material: **Clay** ☐ Pipe Lined
Invert Depth: **12.92** (ft.) Flow Characteristics: **Fast**
Deposits: ☐ None ☐ Mud ☐ Sludge ☒ **Debris** ☐ Grease
Silt Depth: **0.25** (in.) Deposits Extent: **Light**
Infiltration: **None** Pipe Seal Cond: **Sound**

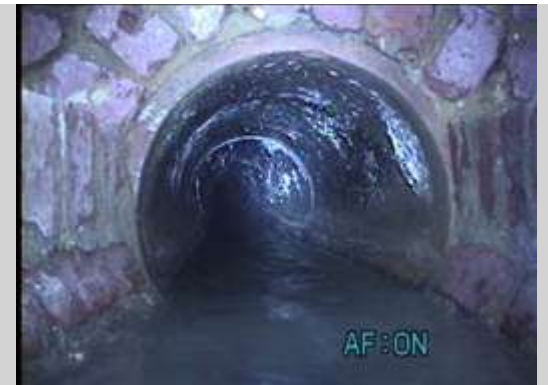
6 O'Clock Inflow

Pipe Height: **12** (in.) Rod and Bar (Angled)
Pipe Material: **Clay** ☐ Pipe Lined
Invert Depth: **12.88** (ft.) Flow Characteristics: **Fast**
Deposits: ☐ None ☐ Mud ☐ Sludge ☒ **Debris** ☐ Grease
Silt Depth: **0.25** (in.) Deposits Extent: **Light**
Infiltration: **None** Pipe Seal Cond: **Sound**
